The root cause of a shaft crack

by **Don Silcock**
Bentley Nevada Corporation

Shaft crack shuts down plant

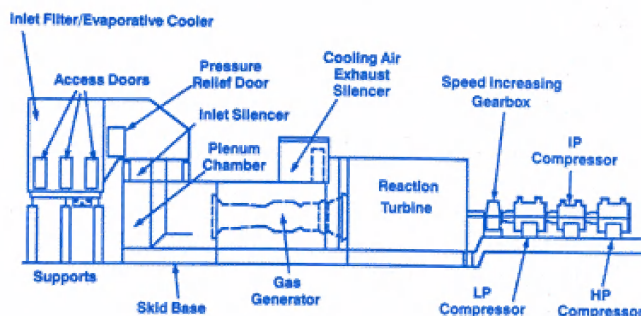
Figure 1

The Synthesis Gas Compressor train is unusual. It does not use a steam turbine driver. Instead, it is driven by a gas generator exhausting into a reaction turbine. The reaction turbine drives three "barrel type" compressors, through a speed-increasing gearbox.

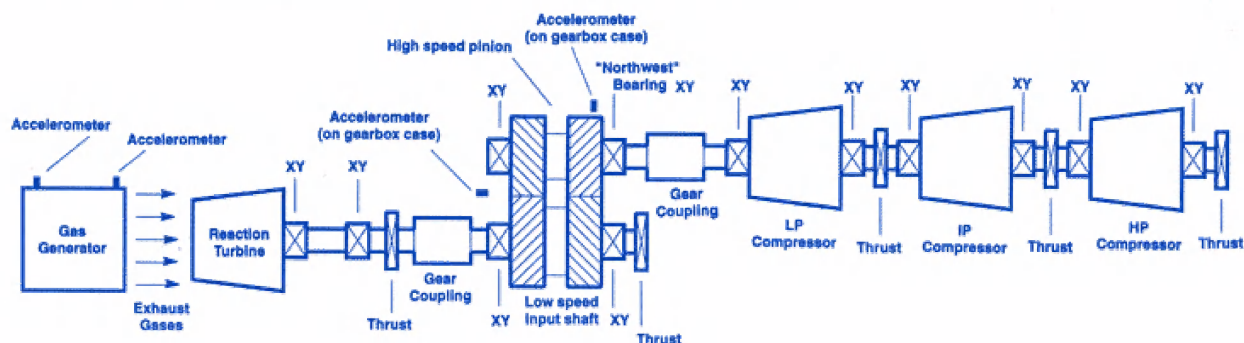
Figure 2

Machine train diagram showing transducer placement.
